Hamilton
Public Works

**Traffic Engineering
Collision Countermeasure Review
Mud: SB – EB off ramp - RHVP
March 31, 2010**

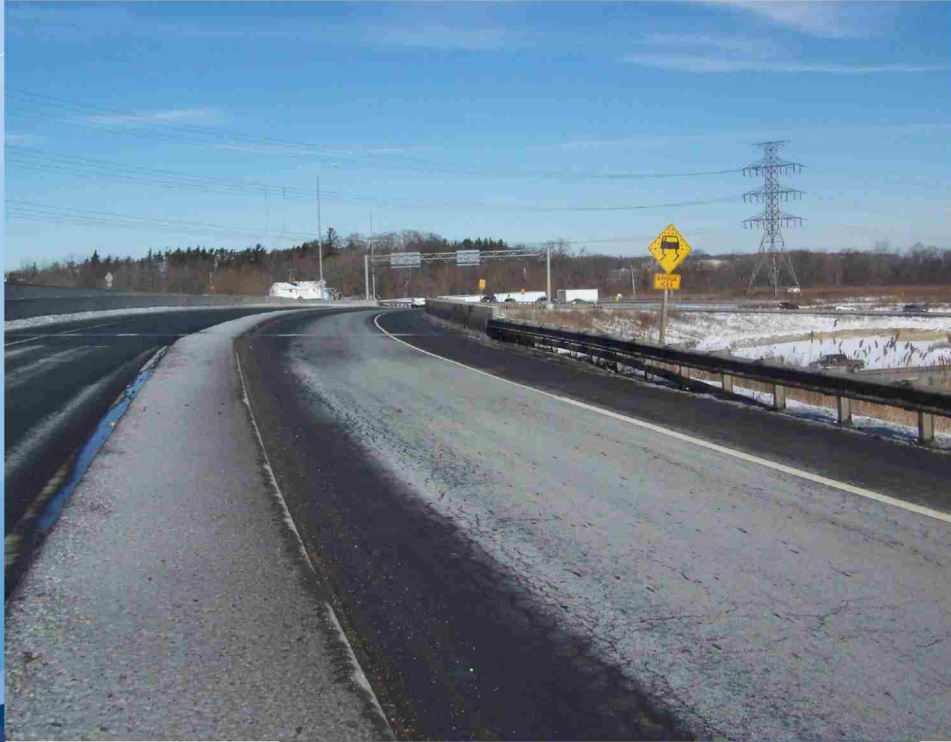
The Ramp – Slippery when wet

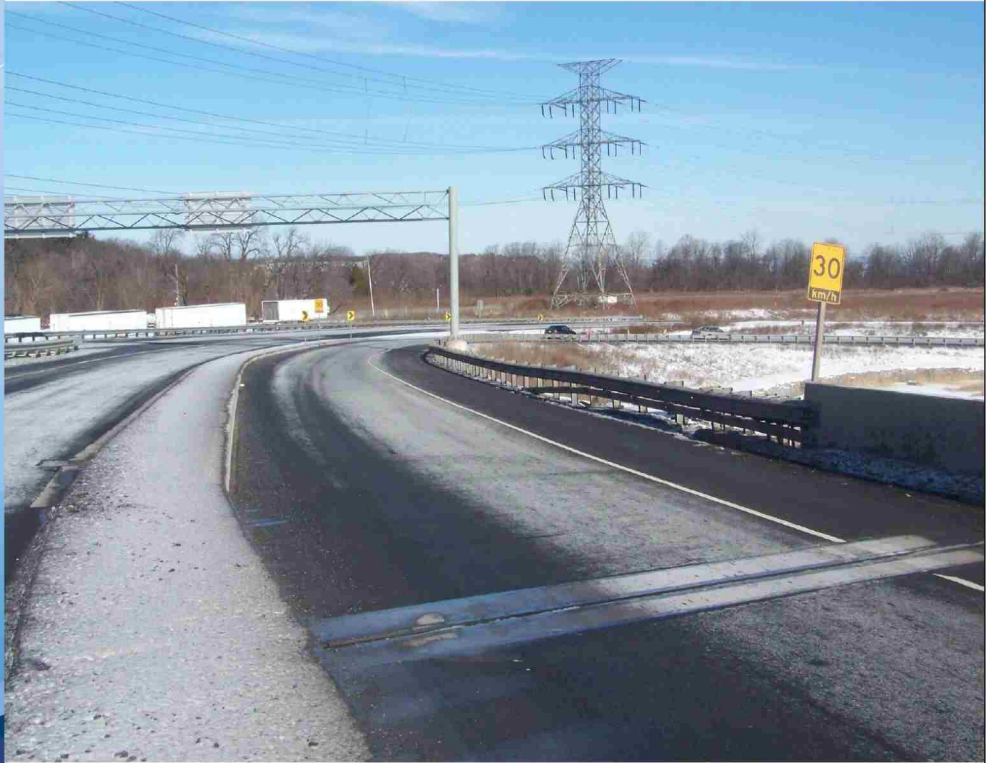
First 30km/h advisory speed limit

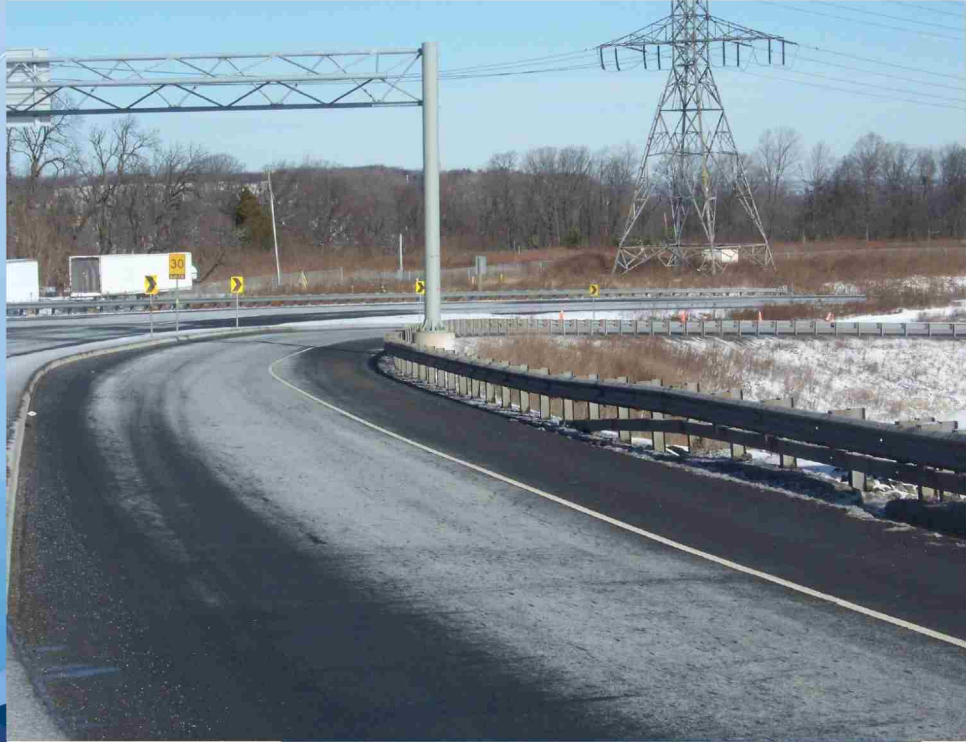
Second 30km/h advisory speed limit

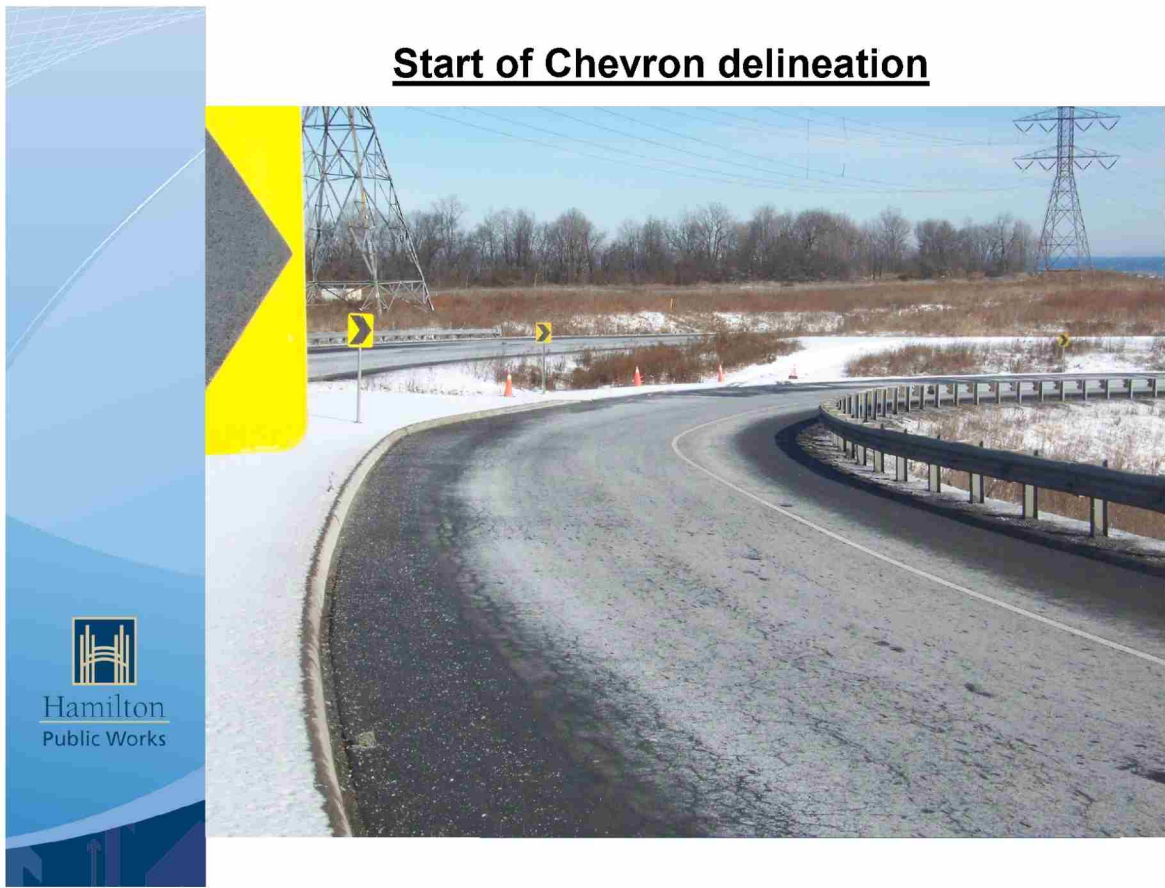
Start of Chevron delineation

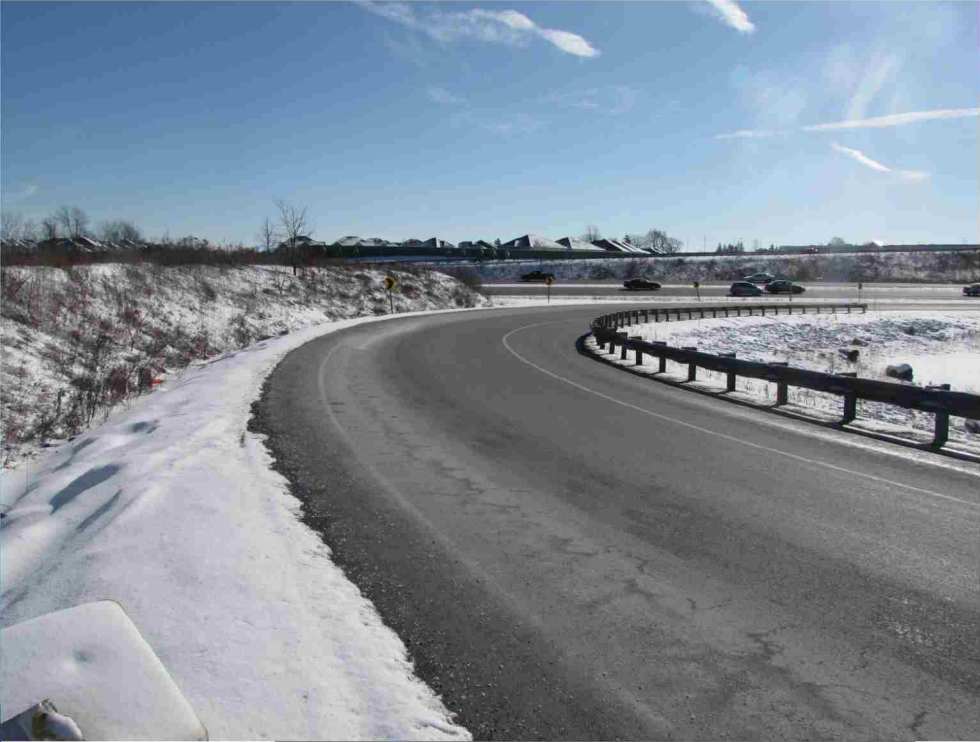
Knocked down Chevrons, run off area

- Chevrons were installed January 2009
- Re-install missing Chevrons
- Over size the 30 km/h signs
- Over size the Chevron signs
- Rumble Strips
