City of Hamilton

Red Hill Valley Parkway Detailed Safety Analysis

FINAL DRAFT

October 2015

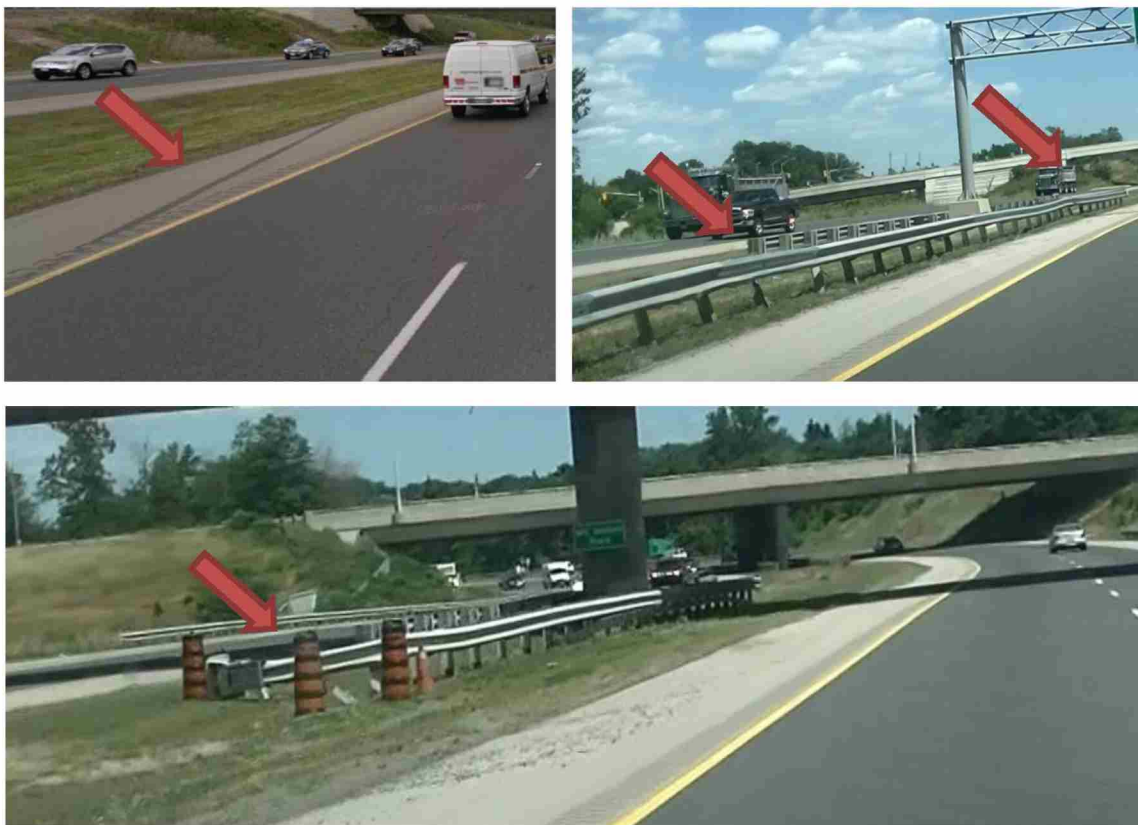
Figure 17: Evidence of loss of control towards the median / collisions with guide rails

The review of collision history revealed a large number of median related collisions including one fatal collision. During the field investigation, evidence of vehicles losing control towards the median was found, including skid marks and damage to guide rails, as illustrated in **Figure 17**. With the exception of the 1,100 m section between Mud Street West and Greenhill Avenue, the median does not have a continuous barrier to protect against median cross-over collisions. The study area was further evaluated regarding the benefits and drawbacks of providing a median barrier. Findings are provided in **Section 7**.

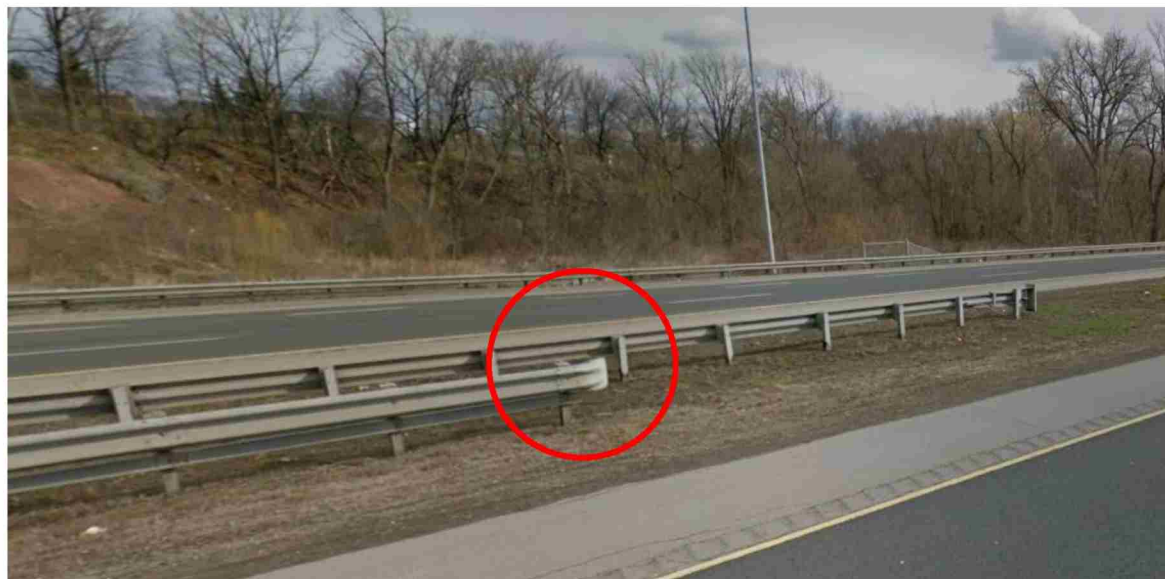
Figure 18: RHVP typical guide rail leaving end treatment

It was also noted that some “fishtail” leaving end treatments at some guide rails protecting bridge structures are located within the clear zone of the opposite direction of traffic (**Figure 18**). When this is the case, the guide rails at the opposite direction do not provide the required length of need to protect the end treatment (**Figure 19**). This type of end treatment can represent a spearing hazard in the event of a frontal collision and should be protected when located within the clear zone.

As highlighted in **Section 5.1**, “fishtail” leaving end treatments at some guide rails protecting bridge structures are located within the clear zone of the opposite direction of traffic, and the approaching end treatment in the opposite direction does not provide the required length of need, exposing vehicle occupants to a spearing hazard. The City should consider replacing the existing extruder and “fishtail” end treatments with CAT-350 attenuators at bridge structures, which is the recommended end treatment according to the RSM. The City may also choose similar options such as the SMART crash cushion (OPSD 923.483). The estimated cost is \$7,000 per unit.

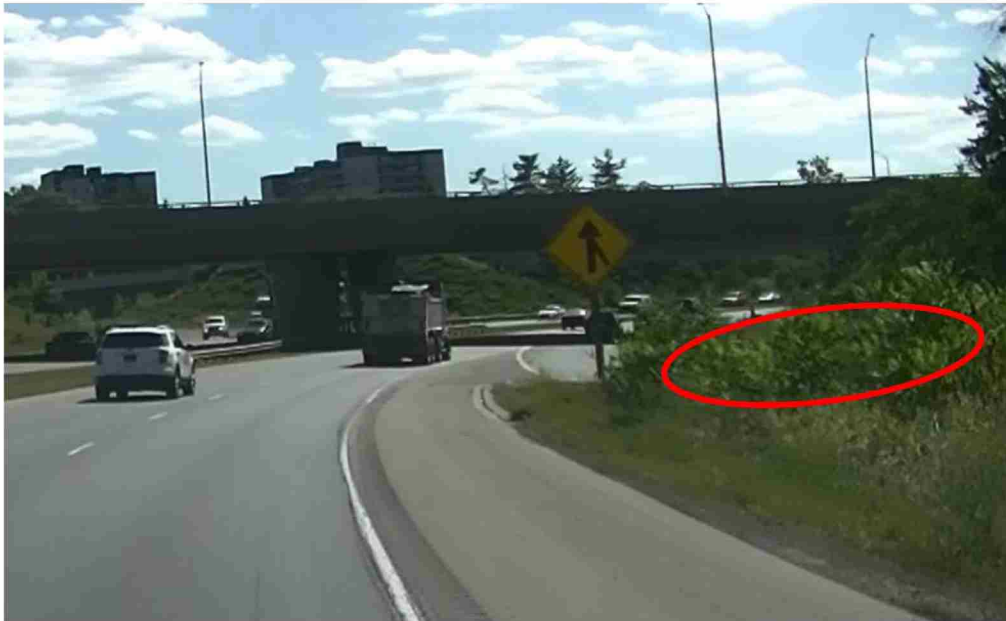
Figure 20: Vegetation obscuring view of vehicles approaching from on-ramp

The RHVP is mostly used by commuter traffic, meaning drivers are expected to be familiar with the road. During the field investigation, it was noted that, occasionally, drivers entering the RHVP from an on-ramp tend to do so in a somewhat aggressive fashion, merging onto the mainline as soon as they reach the dashed line at the acceleration lane. This may be due to a potential perception by drivers that some acceleration lanes along the RHVP are too short (especially considering the high operating speeds as shown in **Section 5.2.1**), and may contribute to sideswipe and SMV collisions (as drivers on the mainline swerve to avoid a sideswipe collision with a merging vehicle). Additionally, some on-ramps in the study area present relatively high vegetation that may restrict visibility, to drivers on the mainline, of approaching vehicles from the ramps (**Figure 20**), which has the potential to violate drivers' expectancy related to merging traffic.

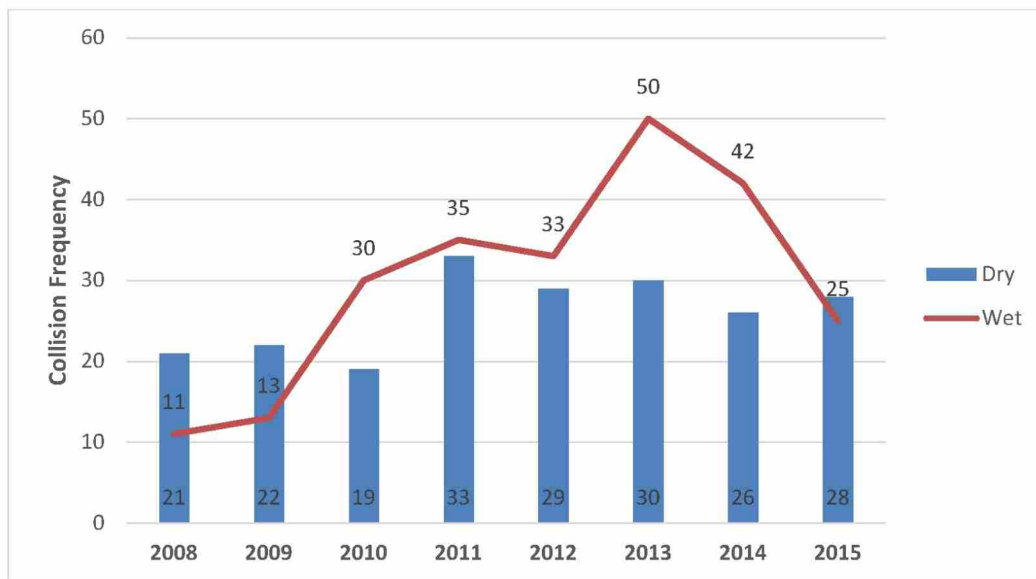
Figure 21: Temporal trend: wet surface collisions

One industry identified characteristic of SMA pavements is that skid resistance is lower by approximately 30 to 40% (under dry conditions) in newer surfaces, reaching normal levels after 6 to 18 months, depending on local conditions and traffic levels.¹⁶ However, as shown in **Figure 21**, the proportion of wet surface collisions seems to be increasing over the years.¹⁷ This suggests that, if low skid resistance is a contributing factor, it is not necessarily related to the normal early life properties of SMA pavements.

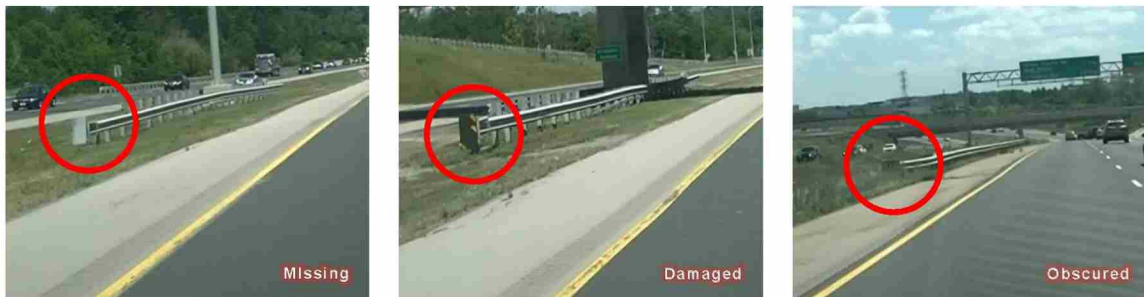
Figure 24: Examples of Missing, Damaged and Obscured Object Marker Signs

Direction	Location	Side	Issue
EB	Upstream of Dartnall interchange	Left	Obscured by vegetation
EB	Upstream of Stone Church/Mud interchange	Left	Obscured by vegetation
NB	Underneath Mud overpass	Left	Obscured by vegetation
NB	Downstream of Mud interchange	Left	Obscured by vegetation
NB	Downstream of Mud interchange	Right	Missing
NB	Underneath Greenhill overpass	Left	Damaged
NB	Downstream of Greenhill interchange	Left	Missing
NB	Underneath railway overpass btwn Greenhill and King	Left	Damaged
SB	Downstream of Barton interchange	Left	Missing
SB	Underneath Mud overpass	Left	Obscured by vegetation
SB	Underneath Pritchard overpass	Left	Damaged / Obscured by vegetation
SB	Downstream of Pritchard overpass	Left	Missing

Additionally, as identified in **Section 5.4.2**, **Table 7**, several guide rail approach end treatments were found to have missing, damaged, or obscured OBJECT MARKER signs (Wa-33). These signs should be installed, replaced, or made visible by trimming the vegetation, respectively. The estimated cost is approximately \$500 per sign.

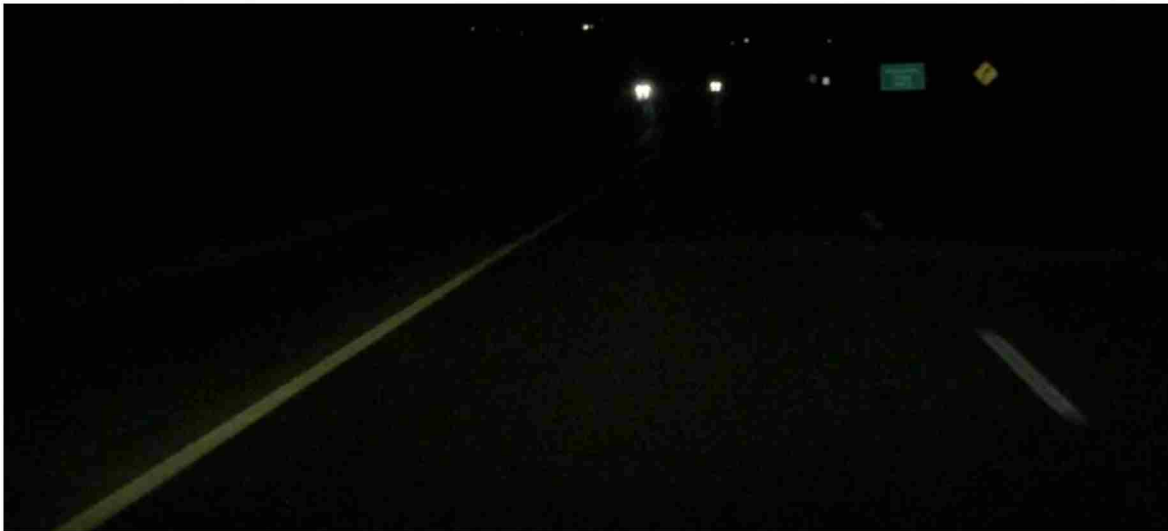
Figure 26: Pavement markings during nighttime condition (without PRPMs)

It was also observed that, where present, guide rails or concrete barriers on the median are not visible due to the lack of delineation along these devices.
