ANALYSIS OF FRICTION ON THE RHVP

RED HILL VALLEY PARKWAY INQUIRY

November 2022

FM Consultants

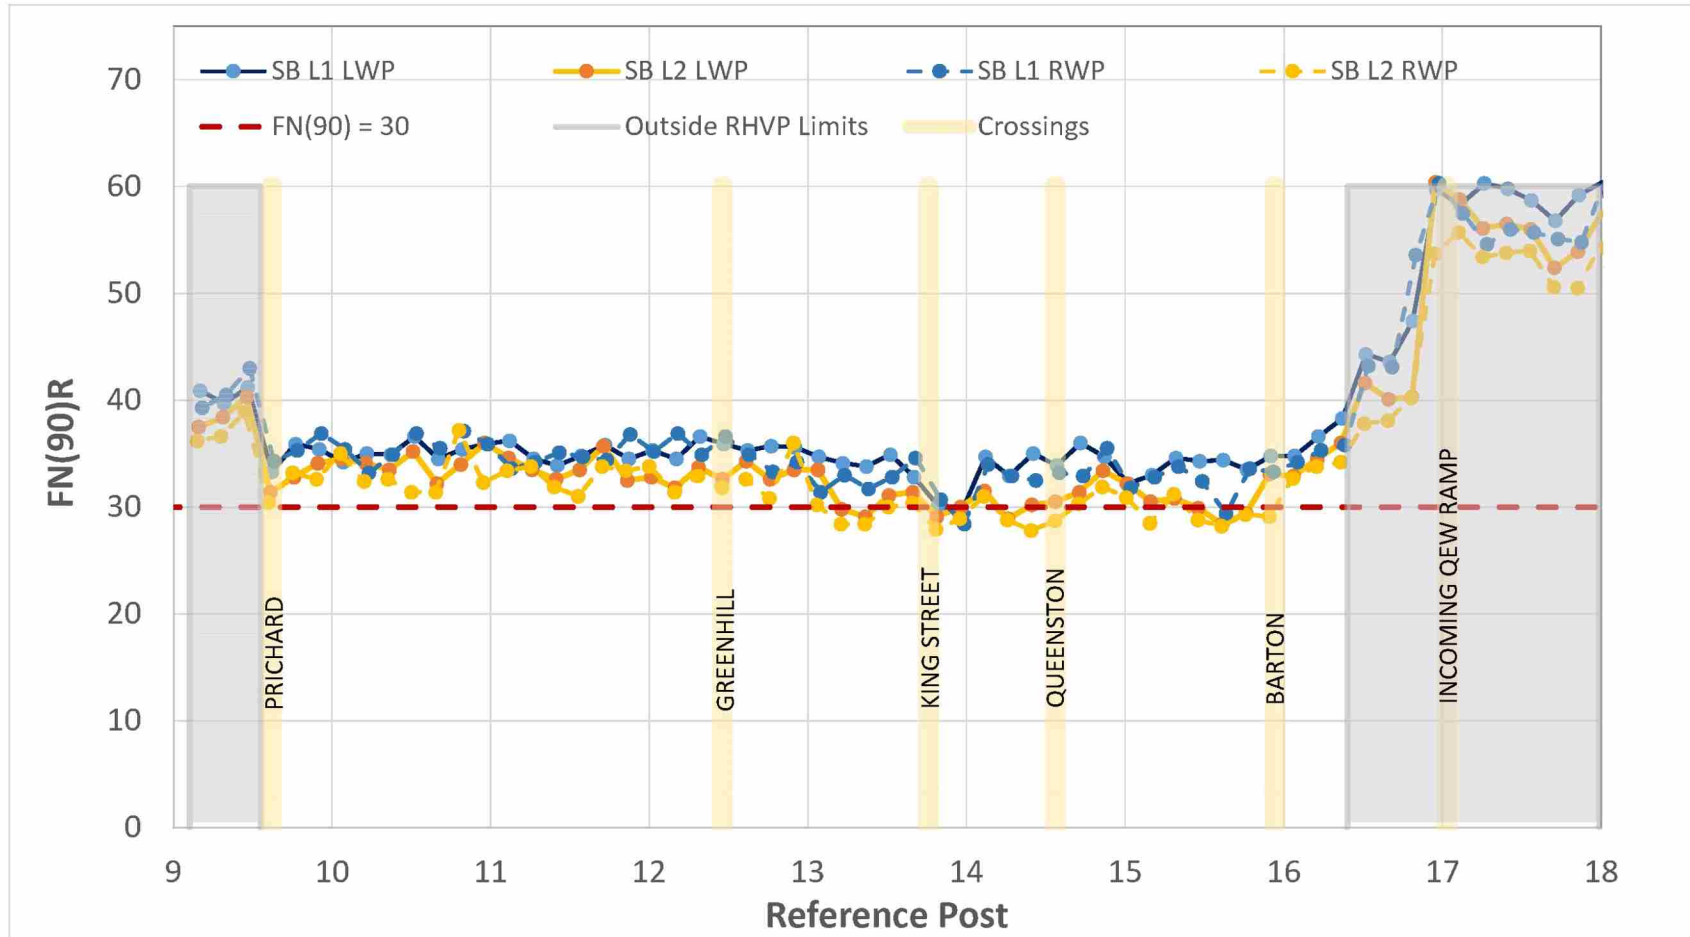
Figure 3. May 2019 Friction Measurements by ARA before resurfacing in the Southbound direction

Notes: The reference post is the chainage as provided in the files submitted by ARA. The shaded areas cover sections outside the results at both ends that were taken on different pavements than the RHVP SMA surface that was paved in 2007.

To illustrate the trend along the section investigated, Figure 3 and Figure 4 present the FN(90)R values measured by ARA on the two main lanes in both directions, in 2019 prior to the resurfacing. It can be observed that several measurements (especially on lane 2 in both directions) are lower than FN(90)R = 30.

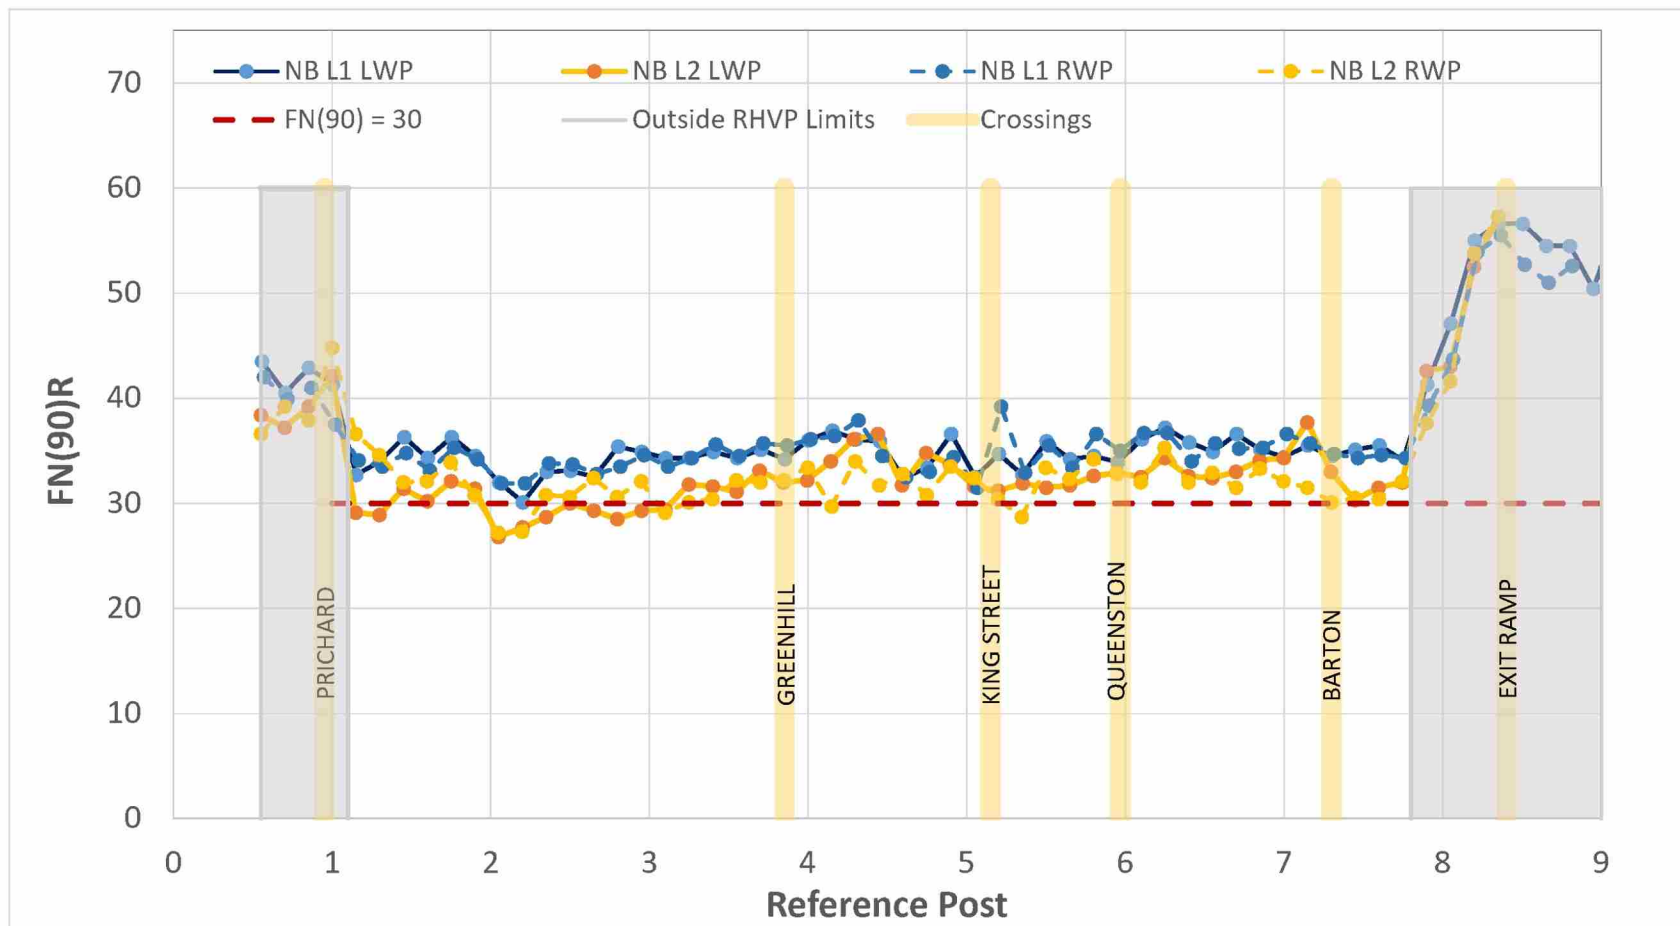
Figure 4. May 2019 Friction Measurements by ARA before resurfacing in the Northbound direction

Notes: The reference post is the chainage as provided in the files submitted by ARA. The shaded areas cover sections outside the results at both ends that were taken on different pavements than the RHVP SMA surface that was paved in 2007.

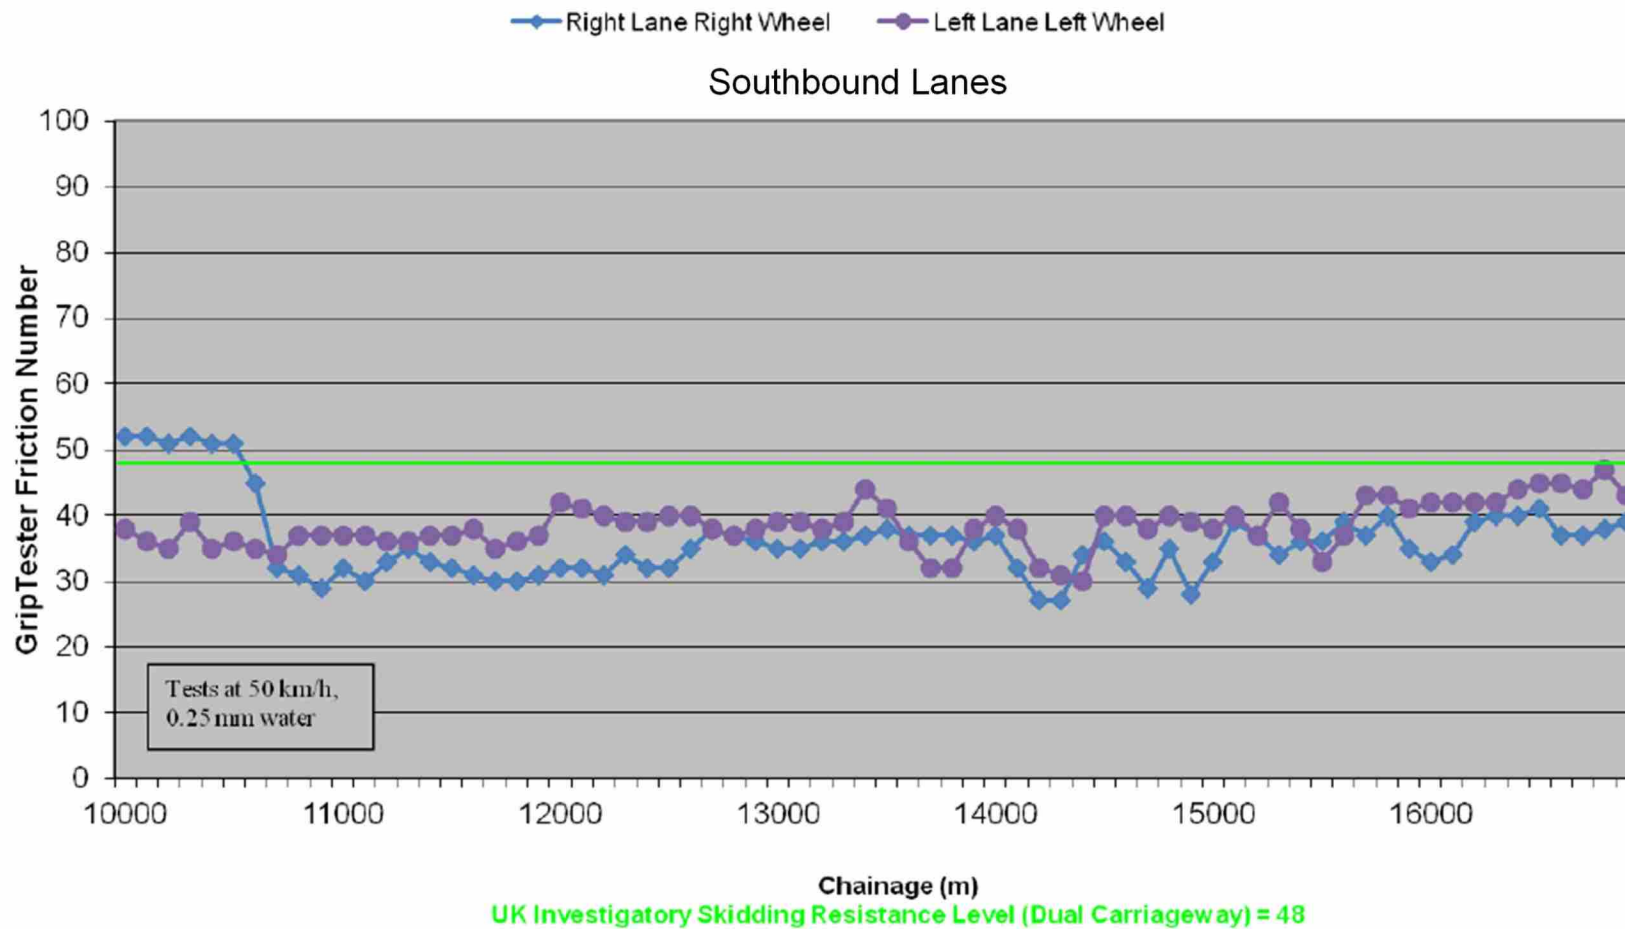
Figure 5. GripTester measurement by Tradewind on the Southbound direction, November 20, 2013 (Tradewind, 2013).

Note: This Figure is reproduced from the Tradewind Report except that in the Tradewind Report the “Southbound Lanes” are referred to as the “Westbound Lanes” as a continuation from the LINC westbound lanes.

Measurements taken by Tradewind for the RHVP are presented in Figure 5 (Southbound lanes) and Figure 6 (Northbound lanes).

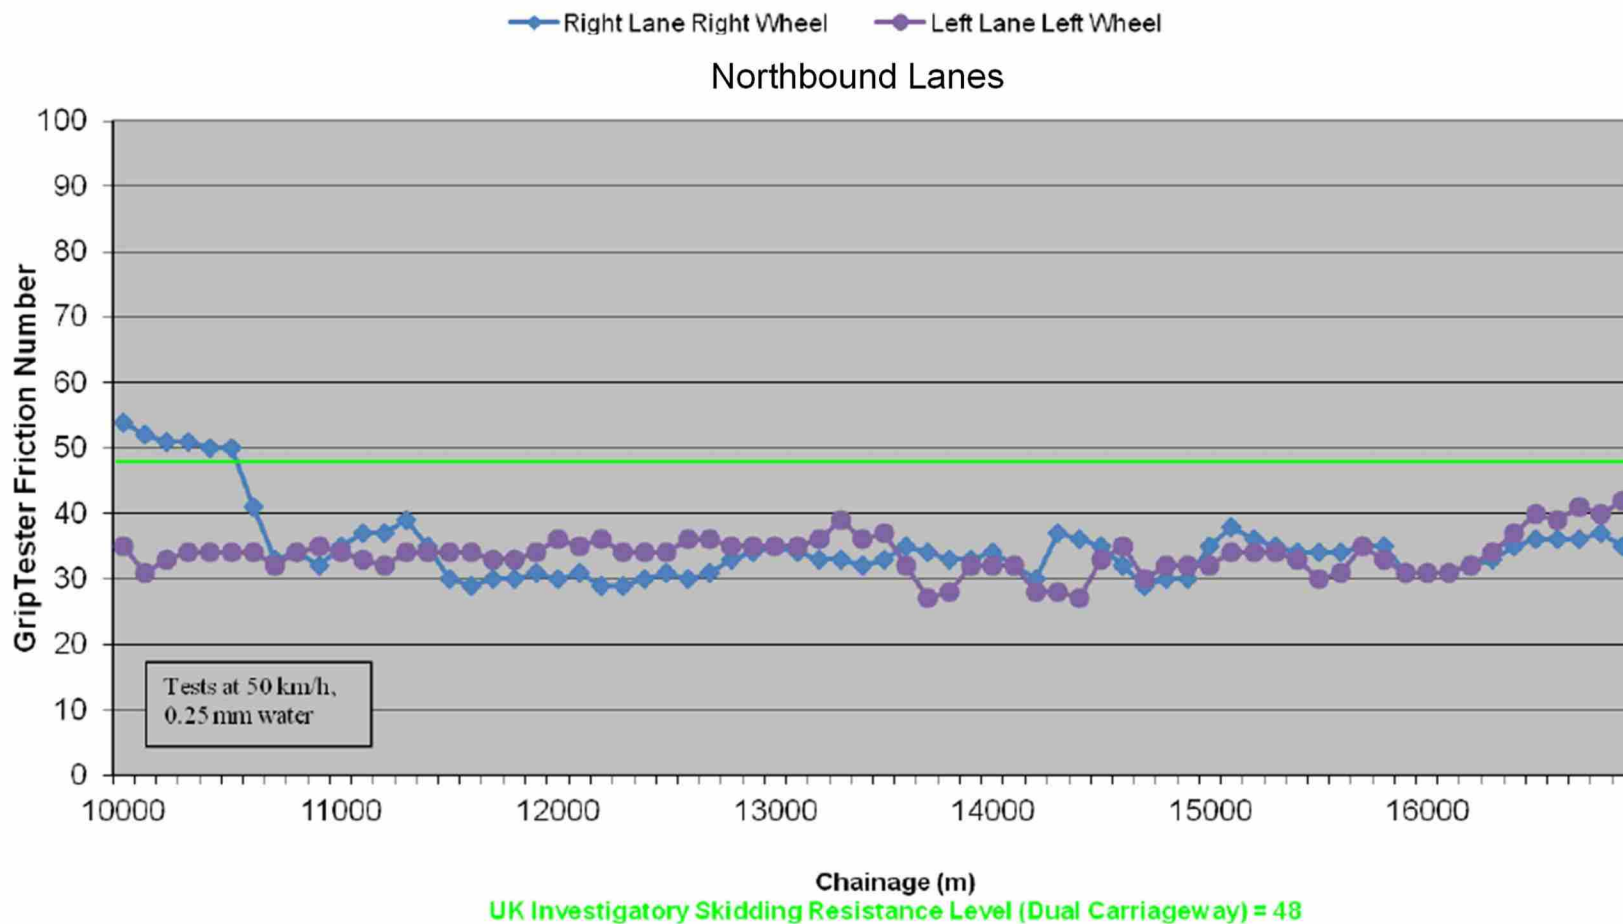
Figure 6. GripTester measurement by Tradewind on the Northbound direction, November 20, 2013 (Tradewind, 2013).

Note: This Figure is reproduced from the Tradewind Report except that in the Tradewind Report the “Northbound Lanes” are referred to as the “Eastbound Lanes” as a continuation from the LINC eastbound lanes.

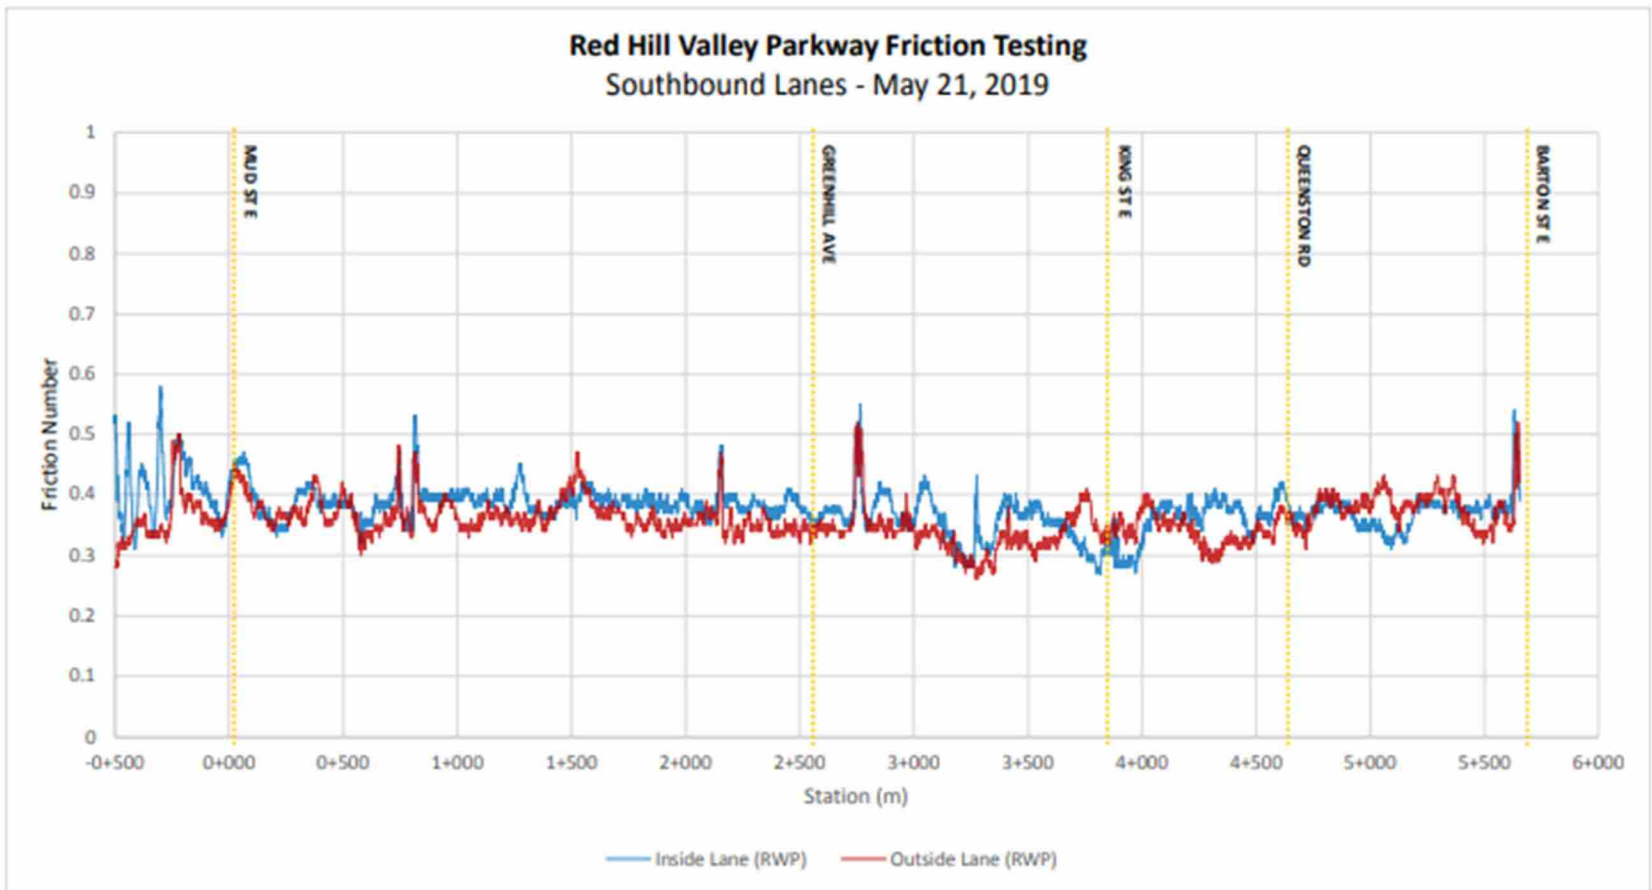
Figure 7. GripTester measurements taken by Englobe pre-resurfacing on the Southbound Lanes, May 2019.

The GN measured by Englobe in the Northbound and Southbound directions of the RHVP are presented in Figure 7 and Figure 8, respectively. It must be noted that the plots on the Y axis of Figures 7 and 8 display the friction coefficient and not the GN (Grip Number). To obtain the GN requires multiplying the friction coefficient by 100; for example, a friction coefficient of 0.4 is GN40.

The Englobe results as shown in Figures 7 and 8 also confirm the presence of localized areas with lower friction, as observed in the Tradewind report.

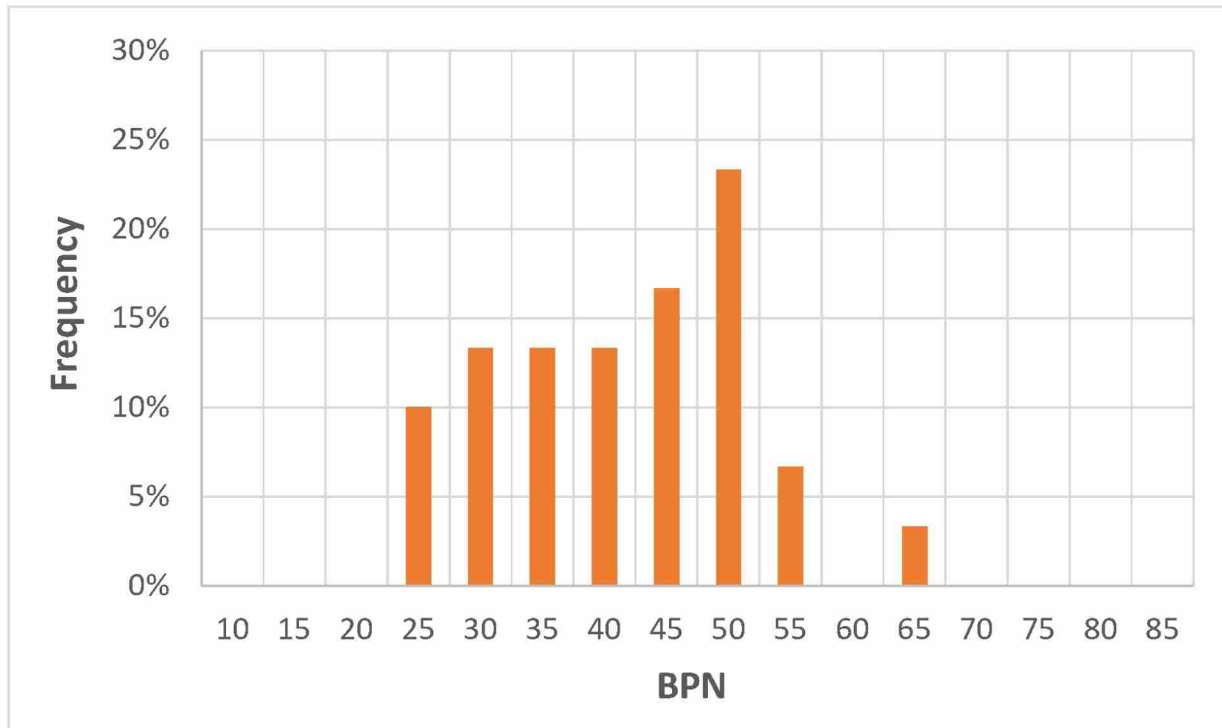
Figure 11. Summary of BPN tests conducted by Golder in December 2017.

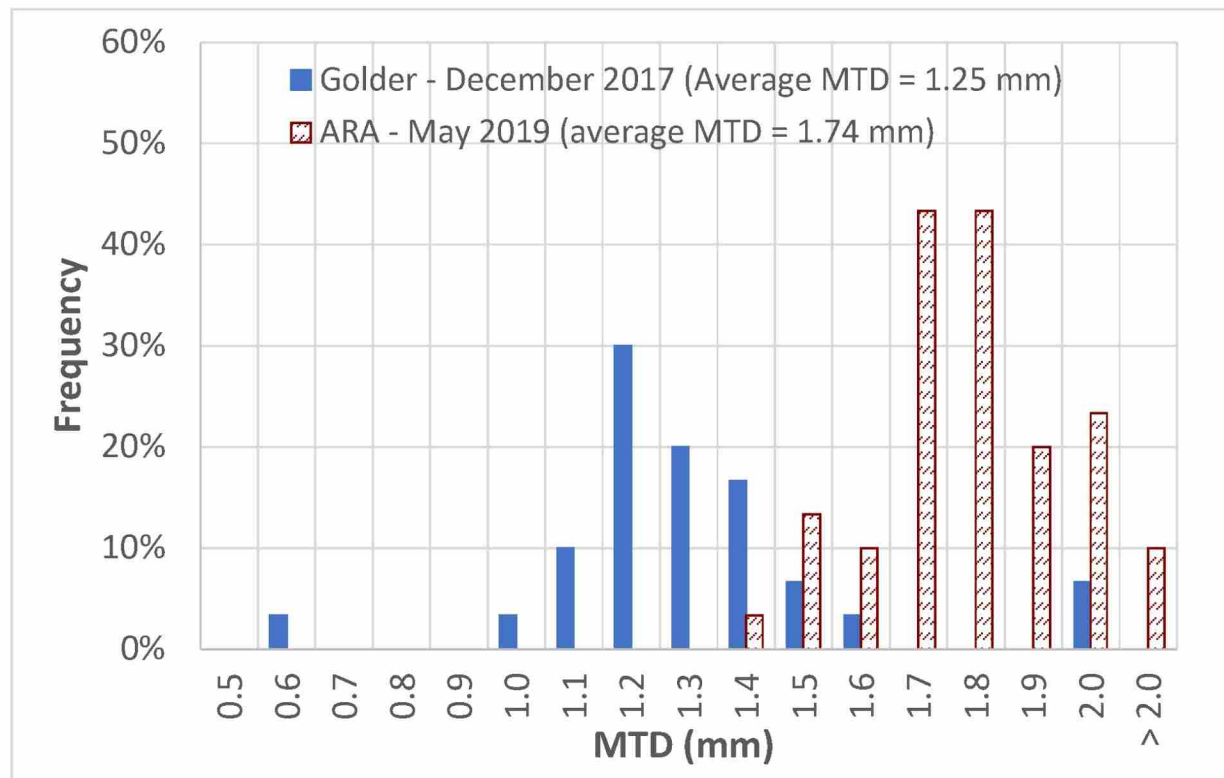
Figure 12. Macrotexture measurements in 2017 by Golder and in May 2019 by ARA.

Macrotexture measurements were conducted using the sand patch method in accordance with ASTM E965 in December 2017 by Golder and May 2019 by ARA pre-resurfacing. These are summarized in Figure 12.

These macrotexture measurements are acceptable and can be described as follows.

The increase in macrotexture values between the Golder and ARA tests may be attributed to pavement surface deterioration. However, in either case, the macrotexture values are considered appropriate and similar to those observed in other SMA surfaces. Thus, I am not of the view that macrotexture was a contributing factor to the high number of collision and the high percentage of collisions on wet surfaces.

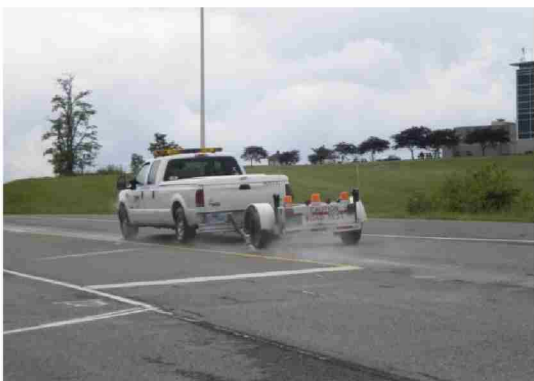
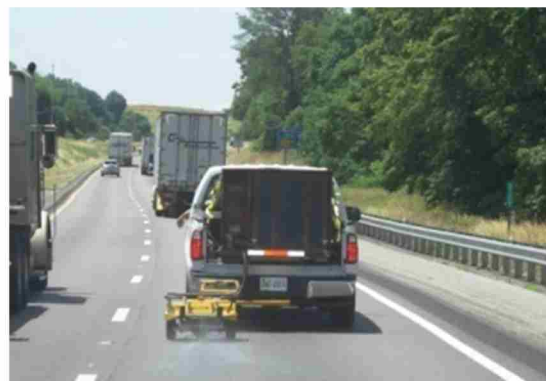
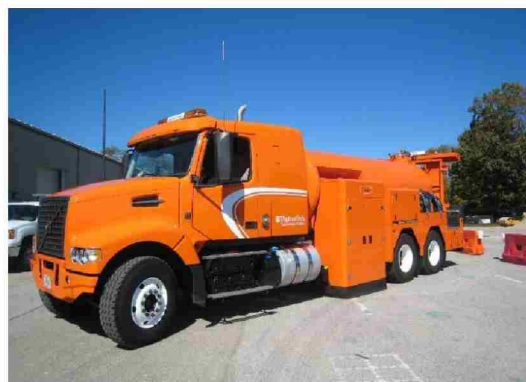
(a) Locked-Wheel Friction Tester

(b) GripTester

(c) SCRIM

Figure 5. Examples of Friction Testers

Many different devices have been developed over the years to measure pavement friction. They all rely on the broad principle of sliding rubber over a wet road surface and measuring the reaction forces developed. These forces are used to compute the coefficient of friction discussed previously and, in some cases, this number is multiplied by 100 to compute what standards call Friction Number (FN), Skid Number (SN), or Grip Number (GN). Figure 5 shows some of the most commonly used friction measuring equipment for roadways.

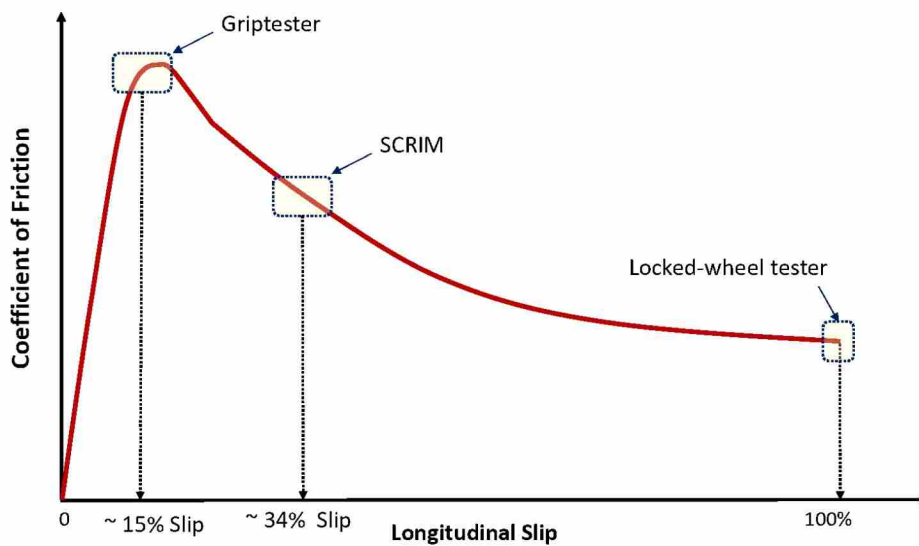
Figure 6. Illustration of the Slip Operational Ranges for Different Friction Measuring Equipment (not to scale).

In contrast, most airports use CFME and report the coefficient of friction, not multiplied by 100. The most common equipment used in these facilities is fixed-slip CFME that measures friction at a low slipping speed. Examples include the GripTester (manufactured by Findlay Irvine). Because the systems use different configurations and operational conditions, the various CFME technologies produce different friction measurements and also different from those obtained with the locked-wheel trailers. The CFME operates at a low slip (Figure 6), so it is impacted mostly by the microtexture of the pavement and is not very sensitive to the surface macrotexture. Their measurements are often complemented by macrotexture measurements. As the reduction of friction with increasing slip depend on the macrotexture of the pavement, the relationship between the measurements of different friction measuring equipment is also a function of the macrotexture. The difference is higher for lower values of macrotexture.
