Analysis of Aggregate Testing and Evaluation of the Coarse Aggregate used in RHVP Pavement Surface Course

Prepared by: Hassan Baaj, Ph.D. P.Eng. *Expert in Pavement Engineering and Construction Materials*

Prepared for the RED HILL VALLEY PARKWAY INQUIRY

February 2023

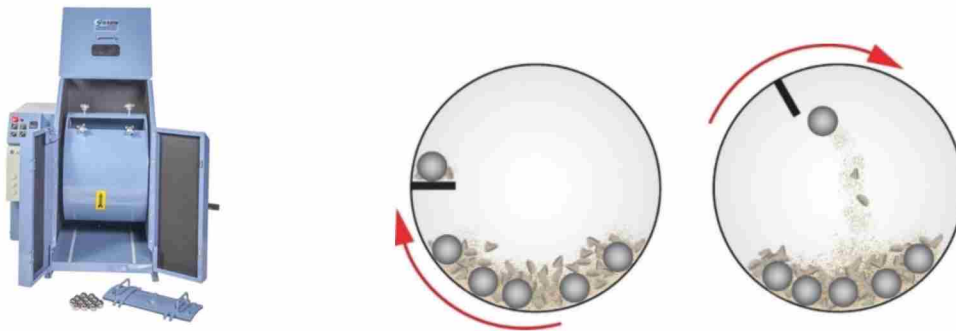
Figure 1. Picture of the Los Angeles apparatus showing the abrasive charge illustrating the concept of the test⁴.

The Los Angeles (“LA”) Abrasion Test³ (Figure 1) is a commonly used test to evaluate the resistance to abrasion of coarse aggregates. The LA Test tries to simulate the abrasion that happens to the aggregates during the different stages of aggregate manufacturing, handling, and transportation and then the stages of asphalt production and road construction, such as mixing in the asphalt plant, placing and compaction using heavy and sometimes vibratory compactors. In addition, the granular skeleton in the asphalt mix plays a significant role in transmitting and attenuating the external loads (caused by heavy traffic) to the underlying layers of the pavement structures. This is particularly important in some asphalt mix types, such as SMA, given their high percentage of coarse aggregates compared to conventional asphalt mixes. In the SMA, the stone-to-stone contact leads to a higher level of stresses transmitted through the coarse aggregates. It is, therefore, more efficient to use more abrasion-resistant aggregates with SMA.

The concept of the test is to place the dry, coarse aggregate sample (coarser than 1.70 mm) in a rotating drum, together with an abrasive charge (47-mm diameter steel balls) and rotate the drum at a specific time or number of rotations. As the drum rotates, the aggregate sample becomes subjected to repeated shocks from the abrasive charge. The aggregate particles start to abrade due to the impact of other aggregate particles and the abrasive charge. Some aggregate particles break down into smaller particles, while others become smaller due to the abrasion and attrition caused by the steel balls. At the end of the test, the aggregates are screened using the 1.70 mm sieve, corresponding to the smallest aggregate size used in the test. The portion of the sample that will pass this sieve represents the mass loss of the mineral aggregates by LA abrasion. The test result is expressed as the percentage of the mass of the aggregates that broke down and passed the 1.70 mm sieve (aggregate loss) of the original mass of the sample before the test. Therefore, a high LA value means that the aggregate is more prone to abrasion, while a low LA value indicates that the aggregate is "tougher" and has better resistance to abrasion by impact.

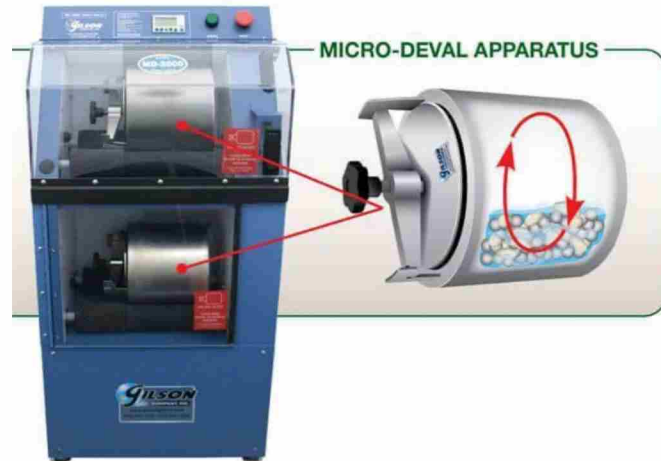
Figure 2. Picture of the Micro-Deval Test Apparatus illustrating the concept of the test⁷.

The MD Test can be conducted on fine and coarse aggregates. For the coarse aggregates, a 1500-grams sample of dry aggregates is prepared and placed in a metal jar (Figure 2). An abrasive charge composed of eleven magnetic steel balls is then introduced. The steel balls used in the MD Test are much smaller than those used in the LA Test (9.5 mm diameter versus 47 mm for the LA Test). A specified amount of water is added before starting the rotation of the jar at the rate of 100rpm. Similar to the LA test, the aggregate sample is then recovered, and the mass of the materials that pass sieve No. 16 (1.18 mm) is determined. This fraction of the sample represents the loss of material by attrition.

The test result is expressed as the percentage of the mass of the aggregates that broke down and passed the 1.18 mm sieve (aggregate loss) of the original mass of the sample before the test. Therefore, a high MD value means that the aggregate is more prone to attrition, while a low MD value indicates that the aggregate is "tougher" and has better resistance to attrition.

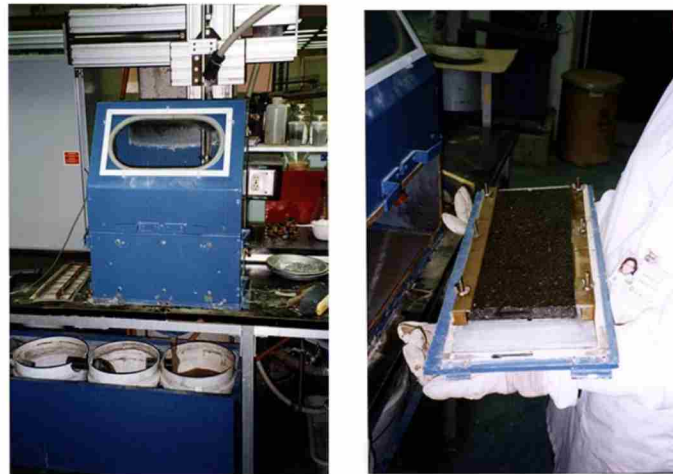
Figure 4. Cpp device (left) and tested specimen (right)¹⁴.

The Cpp varies from one aggregate to another, depending on the petrographic nature of the aggregate. The higher the Cpp, the more the tested aggregates are efficient and, therefore, resistant to wear. According to the requirements defined in the NQ 2560-114 standard, MTQ requires that the Cpp must be a minimum of 0.45.

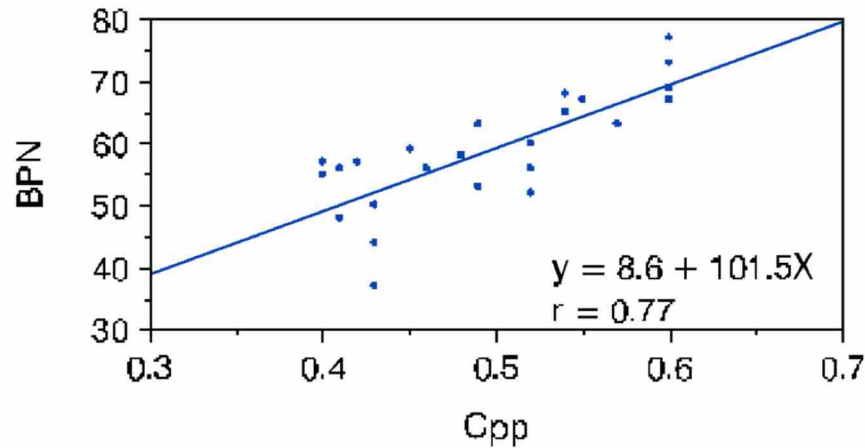
Figure 5. Correlation between Cpp and BPN¹⁵.

The *Laboratoire des Chaussées* of the MTQ conducted a study to evaluate the relationship between the polishing resistance of aggregates, using the Cpp Test method, and the skid resistance of the pavements¹⁵. Six different aggregate types were used in this study (limestone, sandstone, volcanic, dolomite, granitic gneiss, and gravel). The Cpp values ranged from 0.35 to 0.60. The most efficient aggregate is sandstone (Cpp of 0.60), and the least efficient aggregate is limestone (Cpp of 0.35). The Cpp correlates relatively well with the British Pendulum Number (“BPN”) measured on asphalt mixes, as illustrated in Figure 5¹⁵.

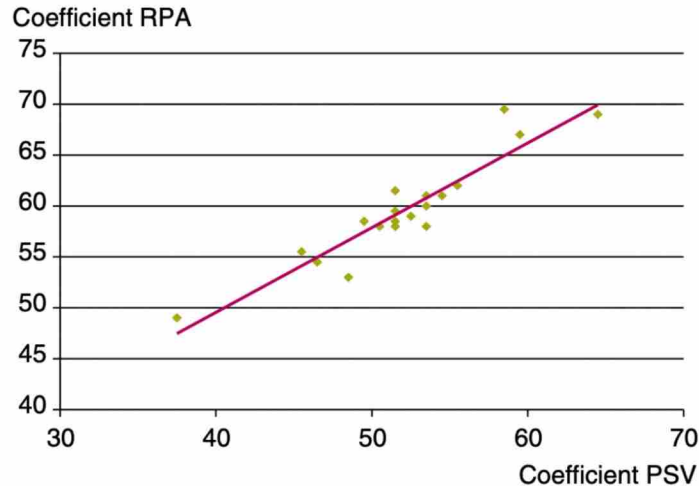
Figure 6. Correlation between RPA and PSV¹⁸

The test used in Québec to determine the Cpp is inspired by a French test called Resistance to Accelerated Polishing (RPA: *Resistance au Polissage Accélééré*), which is standardized in France (XP P 18-580)¹⁷. The polishing in both tests is carried out by spraying the samples with a mixture of abrasive emery (silica powder) and water under a pressure of 10 MPa. The test concept differs from the PSV test, but the two tests correlate well, as illustrated in Figure 6.

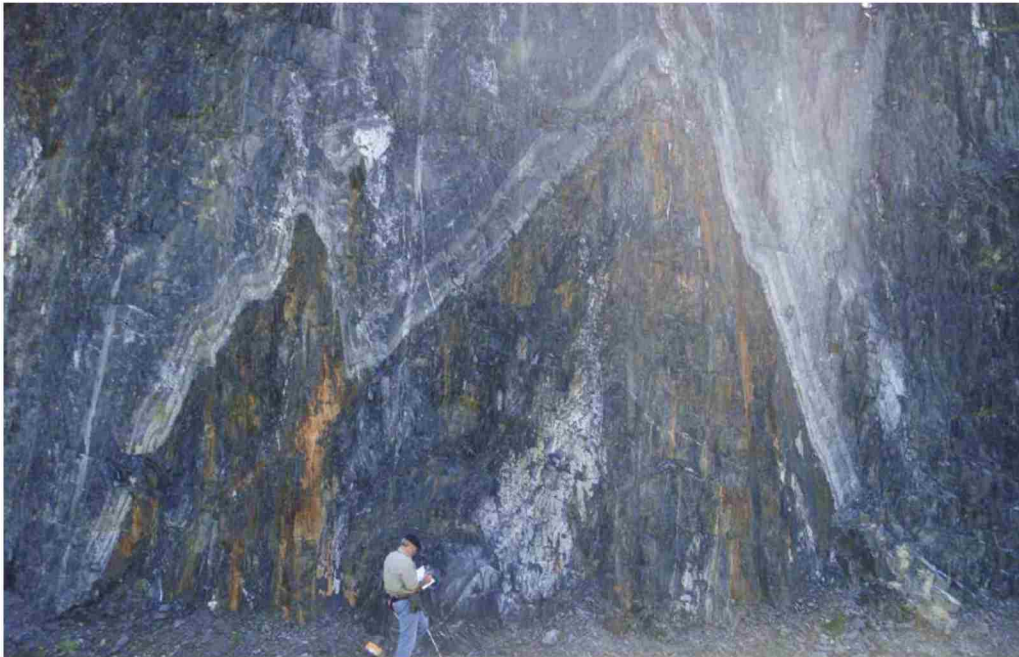
Figure 8. Picture of an igneous or metamorphic massif in Québec (Beauce)³⁴.

various geological formations by different industrial processes of excavation, crushing, screening, washing, or mixing. The properties of the natural material used to produce the aggregates vary in space according to the petrology constrained by the stratification, the variations of facies, the structures, and other geological phenomena. In igneous or metamorphic massifs, the variations can happen in all directions, and it is often unsafe to consider that the characteristics observed in one place extend over a great distance³⁴. Figure 8 shows a picture of an igneous quarry the in the Beauce Region in Québec. The picture shows the variability of the geological formations at an igneous quarry.
