City of Hamilton

Red Hill Valley Parkway Detailed Safety Analysis

FINAL DRAFT

October 2015

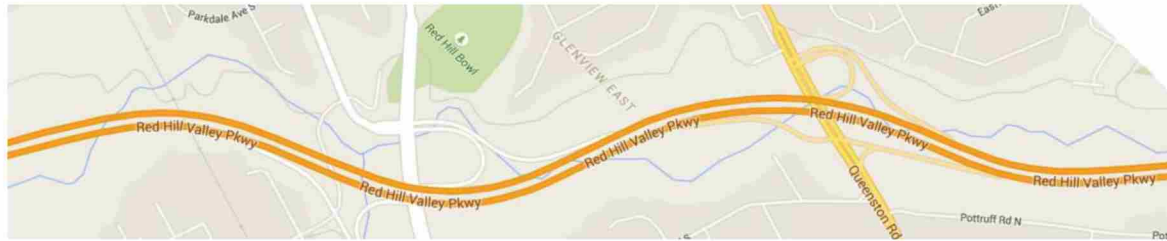
Figure 16: Critical collision locations

- In the northbound direction, a 600-metre section around the King Street interchange (31% of northbound collisions over 7.5% of the RHVP length); and
- In the southbound direction, 100-metre sections near the on-ramps of the Queenston Road, Barton Street and King Street (combined, approximately 30% of southbound collisions over 3.7% of the RHVP length).
- All locations with the highest collision frequencies are located within, on approach to, or leaving horizontal curves (Figure 16).

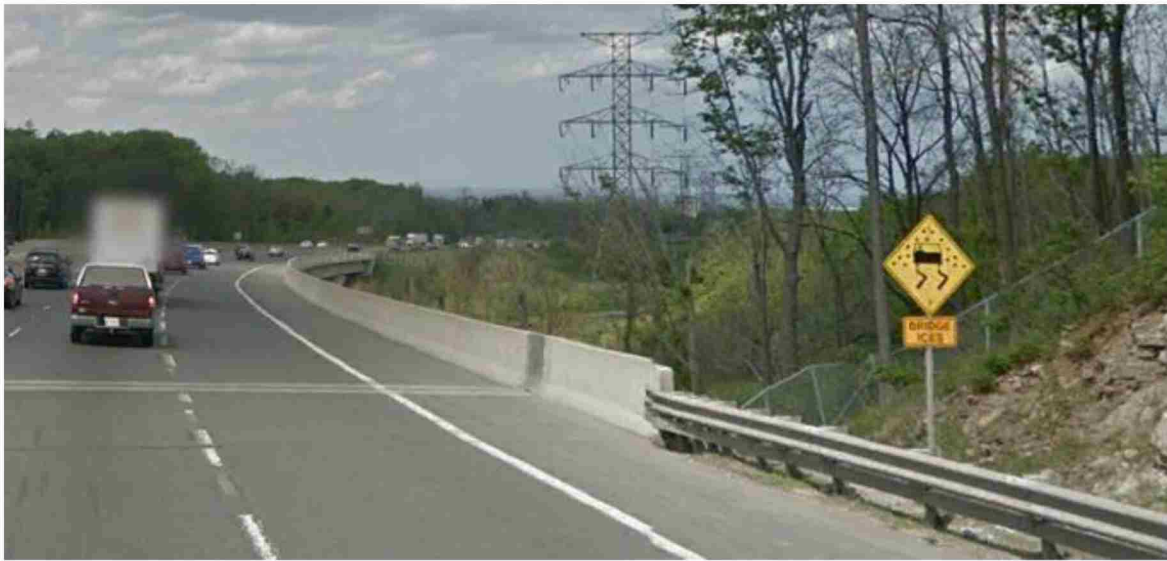
Figure 22: SLIPPERY WHEN WET sign + BRIDGE ICES tab sign

Given the existing proportion of wet pavement collisions (50%), oversized SLIPPERY WHEN WET signs (Wc-105) should be used in the study area. Four of these signs are installed along the RHVP, however they are placed immediately in advance of two bridges (one between Mud Street and Greenhill Avenue, and one between Barton Street and the north end of the study area) and combined with BRIDGE ICES tab signs (**Figure 22**). This tab sign is not part of the current version of OTM Book 6, although it will be included in the updated version, expected to be published in 2015. However, this tab will be recommended for use with the new BRIDGE/ROAD ICES sign, which will have the same design as the WC-23 “Bridge Ices” sign from the Manual of Uniform Traffic Control Devices for Canada (MUTCDC). **Figure 23** illustrates the two different signs.

Because these two signs are intended to convey different messages, the use of the SLIPPERY WHEN WET sign to represent both “slippery when wet” and “bridge ices” conditions is not recommended, as this may create confusion for drivers (although the tab helps clarify the different conditions). This is especially important on the RHVP, since both conditions are possible and should be signed accordingly.

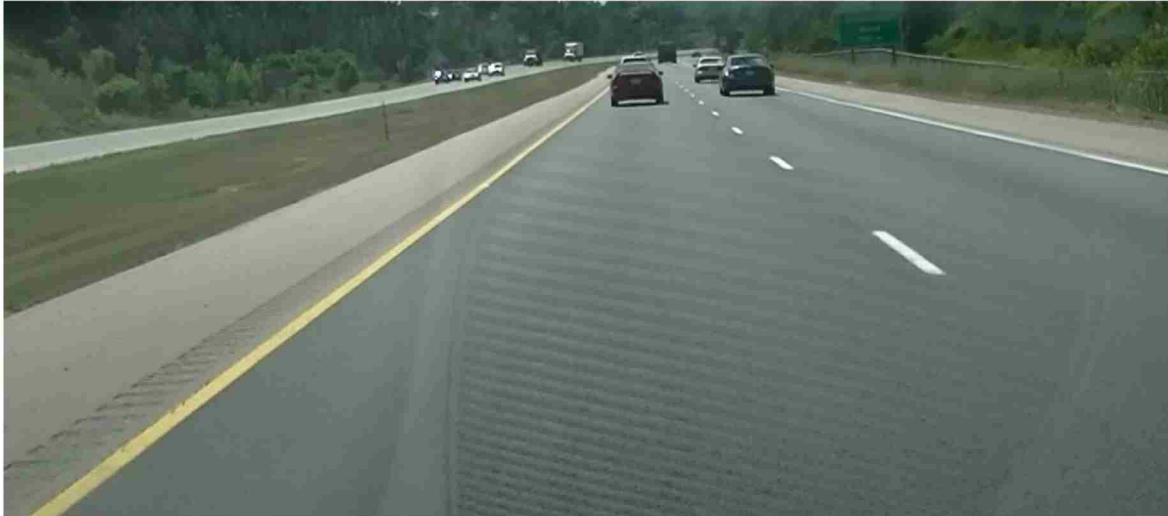
Figure 25: Pavement markings during daytime condition

During night time, however, the absence of illumination makes it difficult for drivers to see the pavement markings ahead of the vehicle. The lane lines become visible for a longer distance south of Greenhill Avenue, where Permanent Raised Pavement Markers (PRPM) are installed. The PRPMs were recommended by CIMA in the 2013 RHVP Safety Review and seem to have improved visibility of lane lines. However, the edge lines remain difficult to see. **Figure 25** through **Figure 27**

illustrate pavement marking visibility under different conditions, including daytime, nighttime without PRPMs, and nighttime with PRPMs.

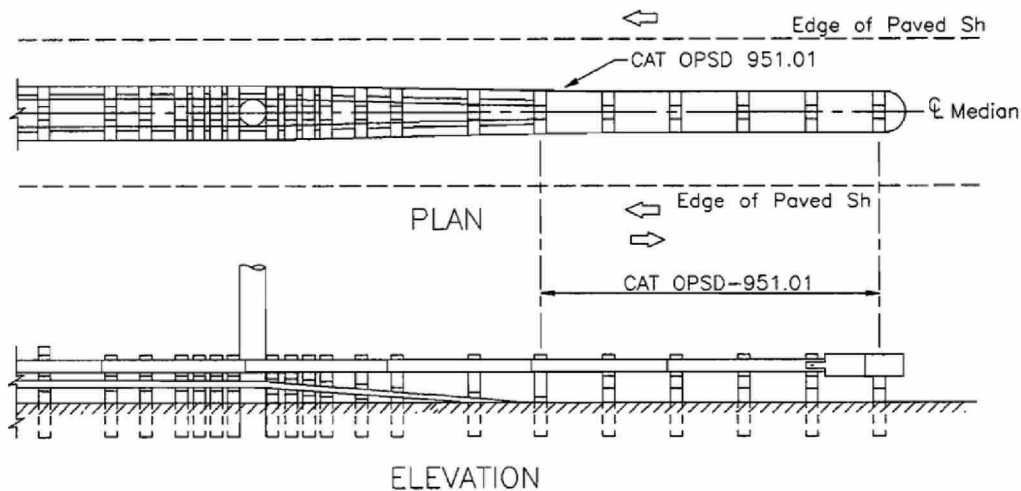
Figure 32: Steel beam protection of structures located on the median³²

As highlighted in **Section 5.1**, “fishtail” leaving end treatments at some guide rails protecting bridge structures are located within the clear zone of the opposite direction of traffic, and the approaching end treatment in the opposite direction does not provide the required length of need, exposing vehicle occupants to a spearing hazard. The City should consider replacing the existing extruder and “fishtail” end treatments with CAT-350 attenuators at bridge structures, which is the recommended end treatment according to the RSM. The City may also choose similar options such as the SMART crash cushion (OPSD 923.483). The estimated cost is \$7,000 per unit.

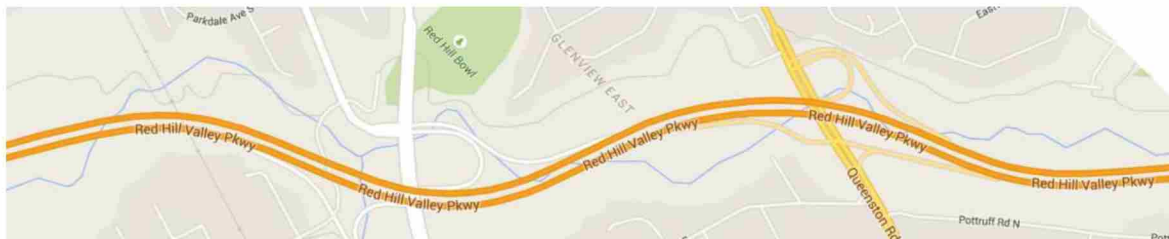
Figure 33: Critical RHVP section for friction testing

In order to determine whether low pavement friction may be contributing to collisions (especially wet surface), the City should consider conducting pavement friction tests under normal conditions as well as under typical wet pavement conditions encountered on the RHVP. Special focus should be given to the curves near the King Street and Queenston Road interchanges (**Figure 33**). The estimated cost to conduct friction testing is \$40,000. Depending on the test results, the City will be able to determine if further action is required.
